HISTORIC AMERICAN BUILDINGS SURVEY
INVENTORY

2. NAME *Orrin Thompson Mansion*

DATE OR PERIOD *1832*
STYLE *Greek Revival*
ARCHITECT
BUILDER *Orrin Thompson*

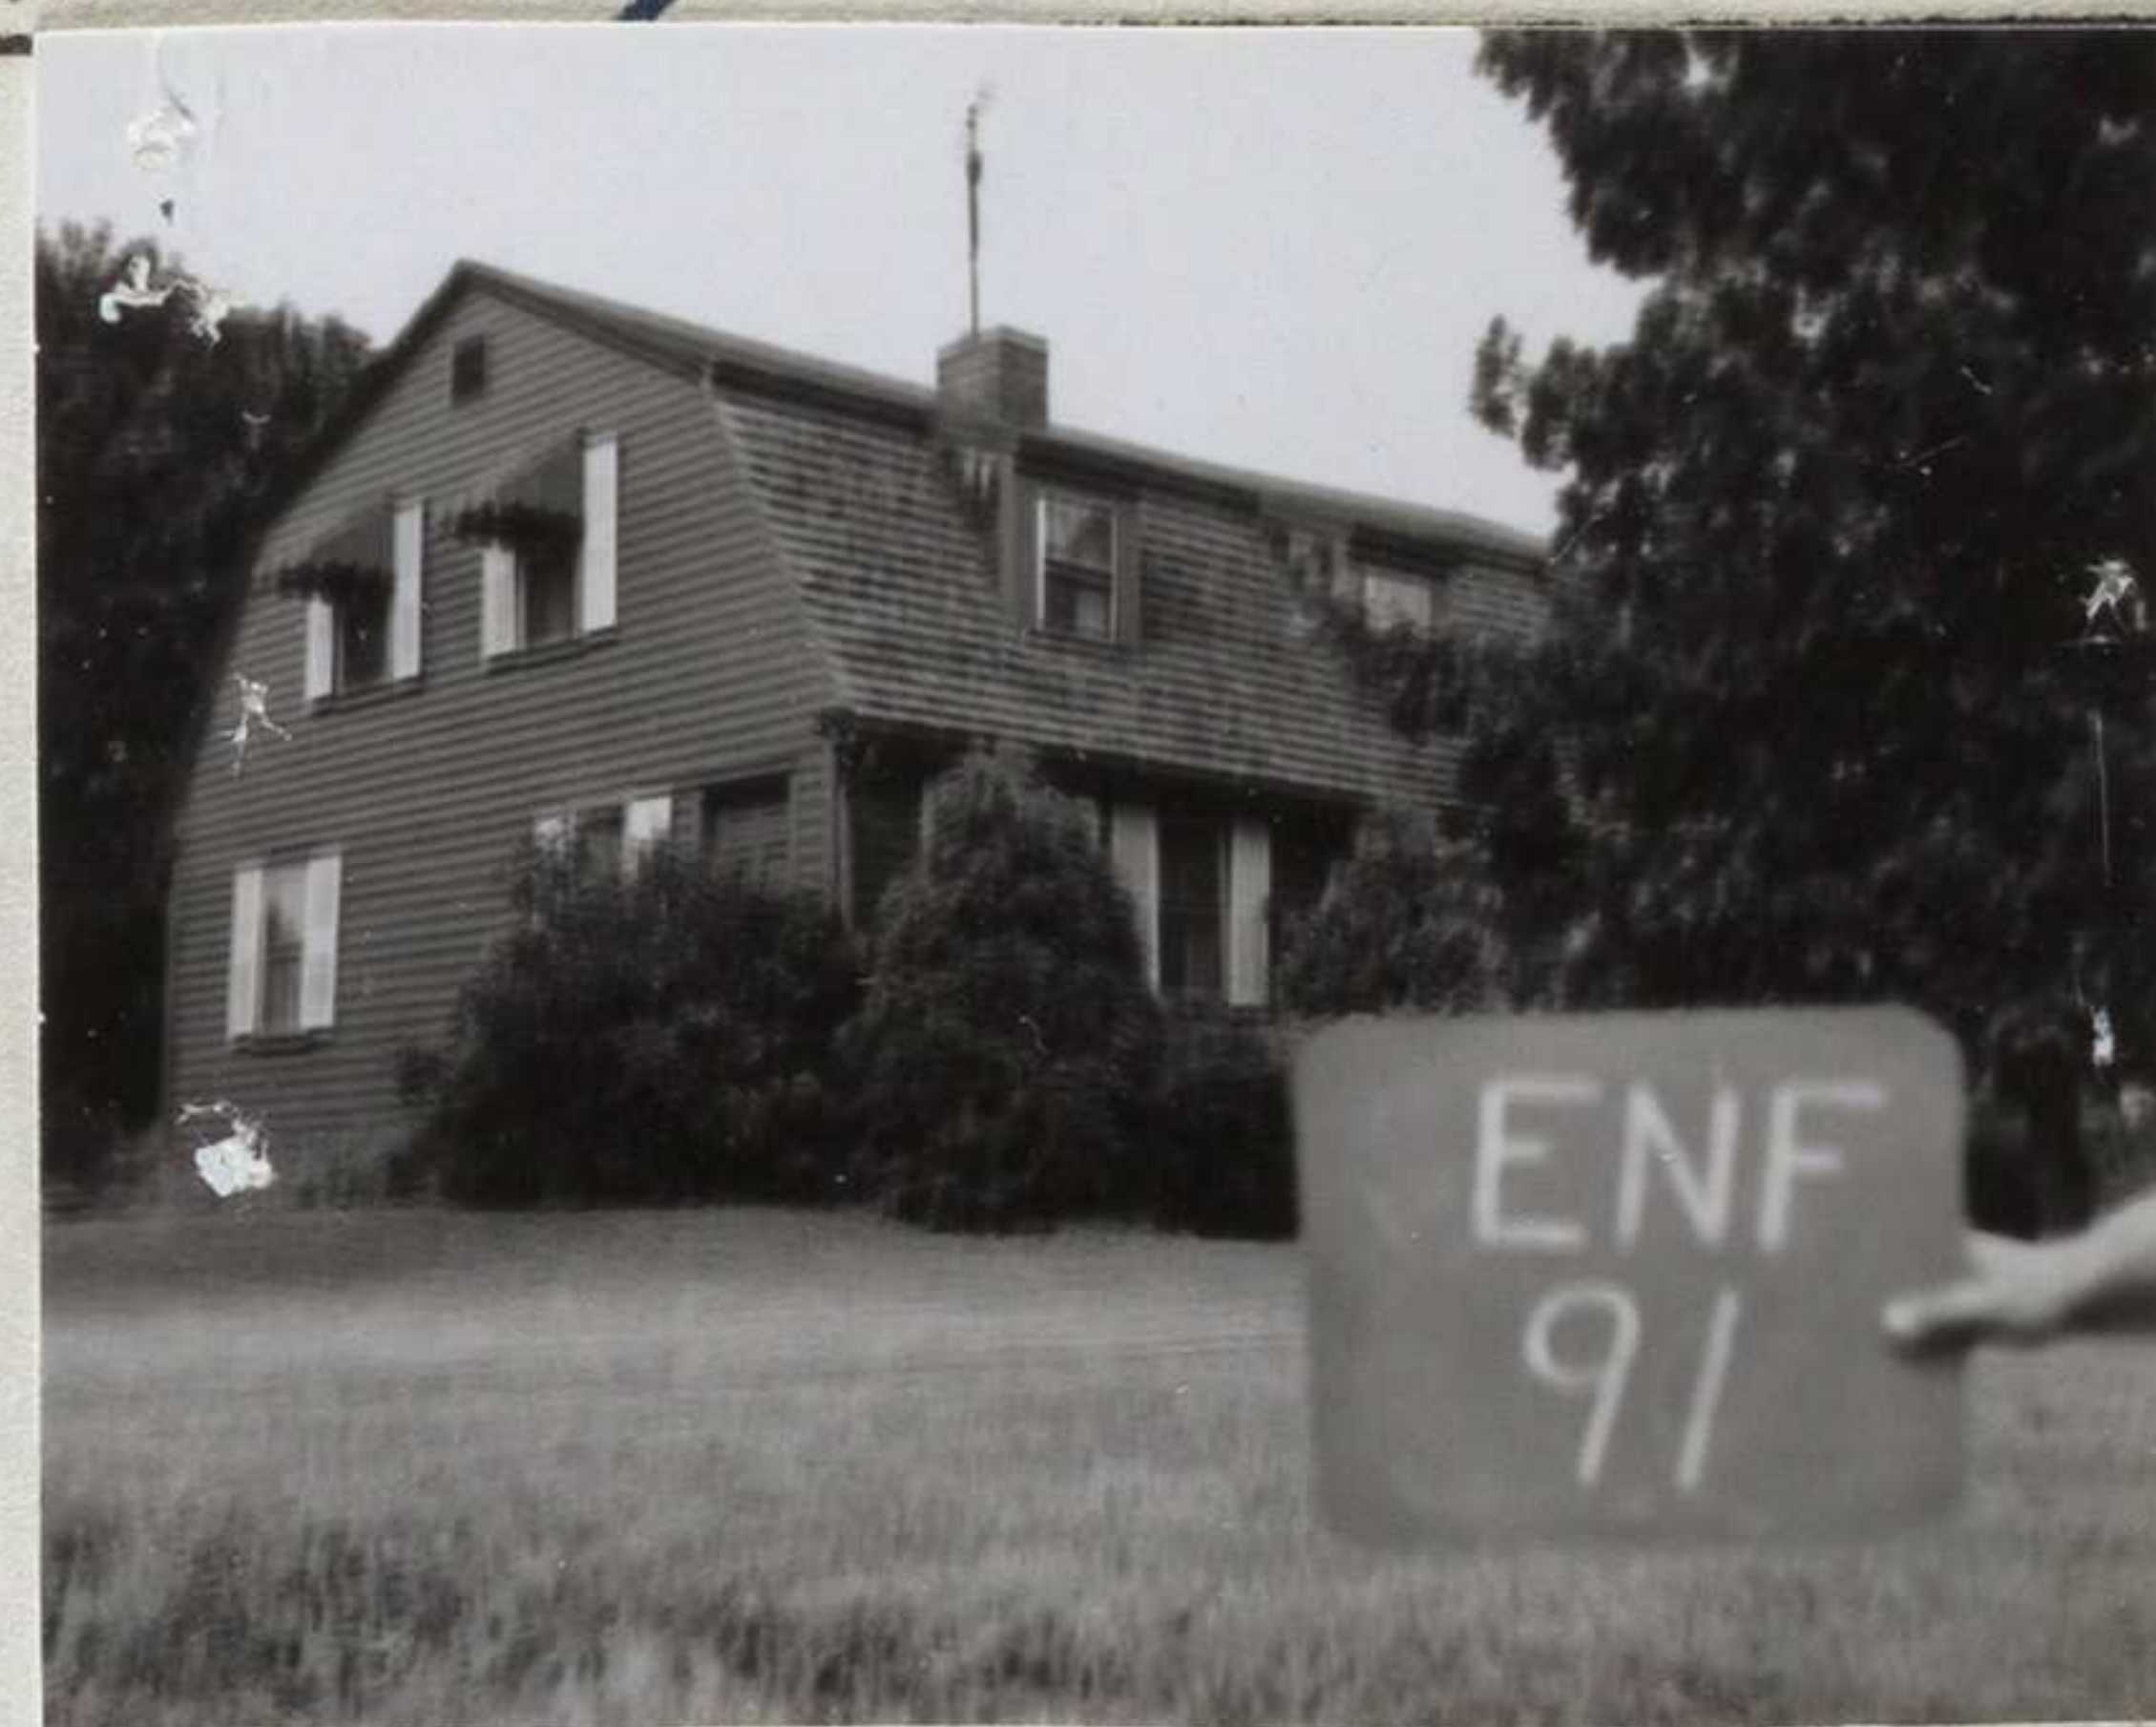
7. PHOTOGRAPH *Enf 91*8. PUBLISHED SOURCES (Author, Title, Pages)
INTERVIEWS, RECORDS, PHOTOS, ETC.9. NAME, ADDRESS AND TITLE OF
RECORDER*Elric J. Endersby*DATE OF RECORD *7/14/67*

4. NOTABLE FEATURES, HISTORICAL SIGNIFICANCE AND DESCRIPTION OPEN TO PUBLIC *No*
- This historically significant house may well have been moved, due to its brick foundation. We located its former owner Mr. Edward Carson and affirmed our guess that it was the Terry homestead. Mr. Carson when conducting some of his misguided renovations actually discovered sketches done when ^{by} Luther Terry as a youth. The central chimney was removed ~~the~~ by Mr. Carson and in the basement he discovered a brick which had had 1783 imbedded into it before it hardened. This, the sketches and other material is now in the possession of Enfield Town Hall. The house has a Ct. pitch gambrel roof over a five bay facade. The doorway is ~~over~~*
5. PHYSICAL CONDITION OF STRUCTURE Endangered *?* Interior *poor* Exterior *fair*

still in place but a single door replaces the original double doors. There is also a coffin door. There are new dormers and shutters and a wing to the rear.

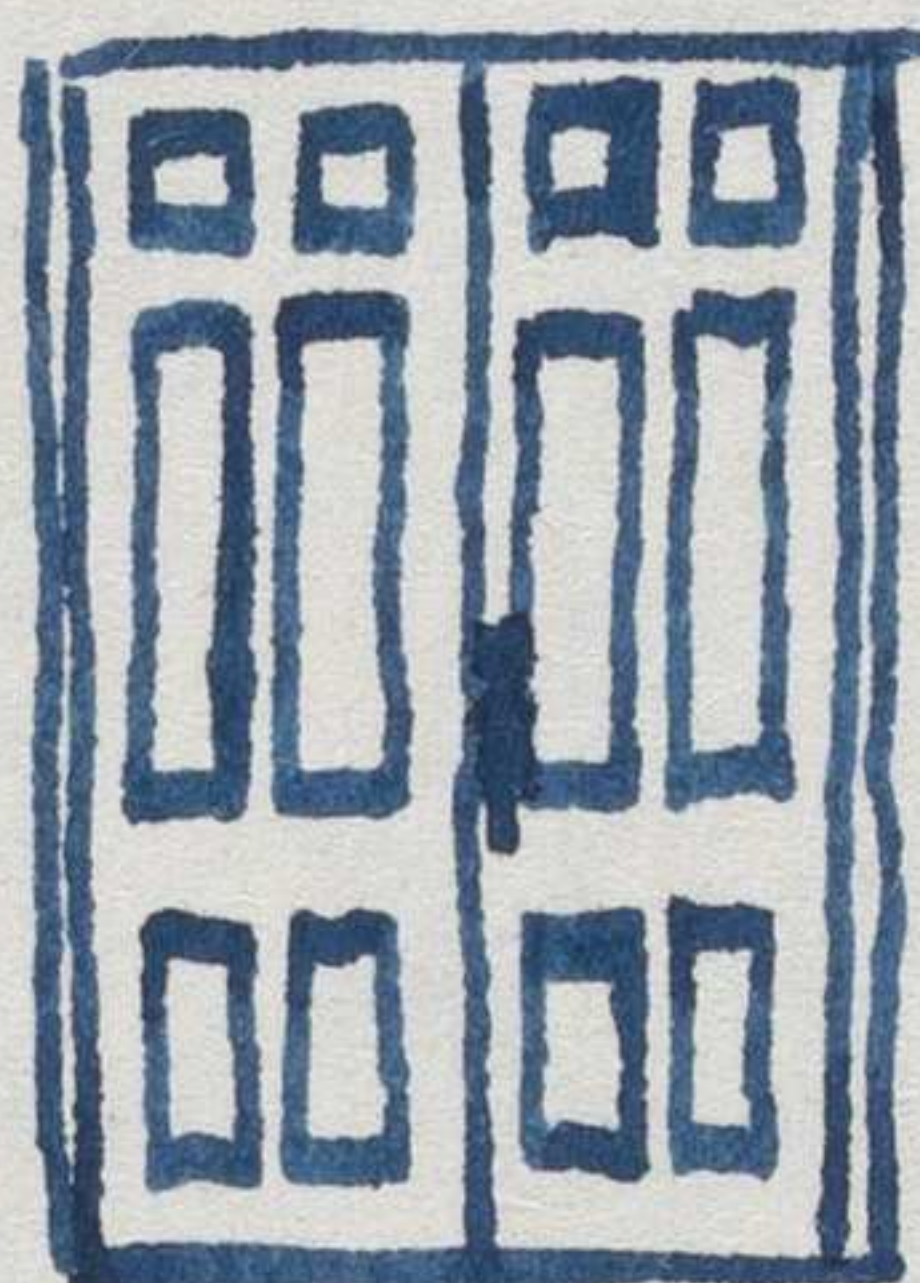
This is one of the three saltbox houses found in Enfield. Although it is quite early it has a brick foundation which probably indicates that it has been moved. The pitch of the roof is quite steep, showing it to be somewhat earlier than the other two saltboxes. The facade has five bays with 6/6 windows which probably replaced 12/12's. The doors are the out-standing exterior feature. Although hidden by a most unfortunate sun porch, the original paneled front doors remain, complete with the original handle over.

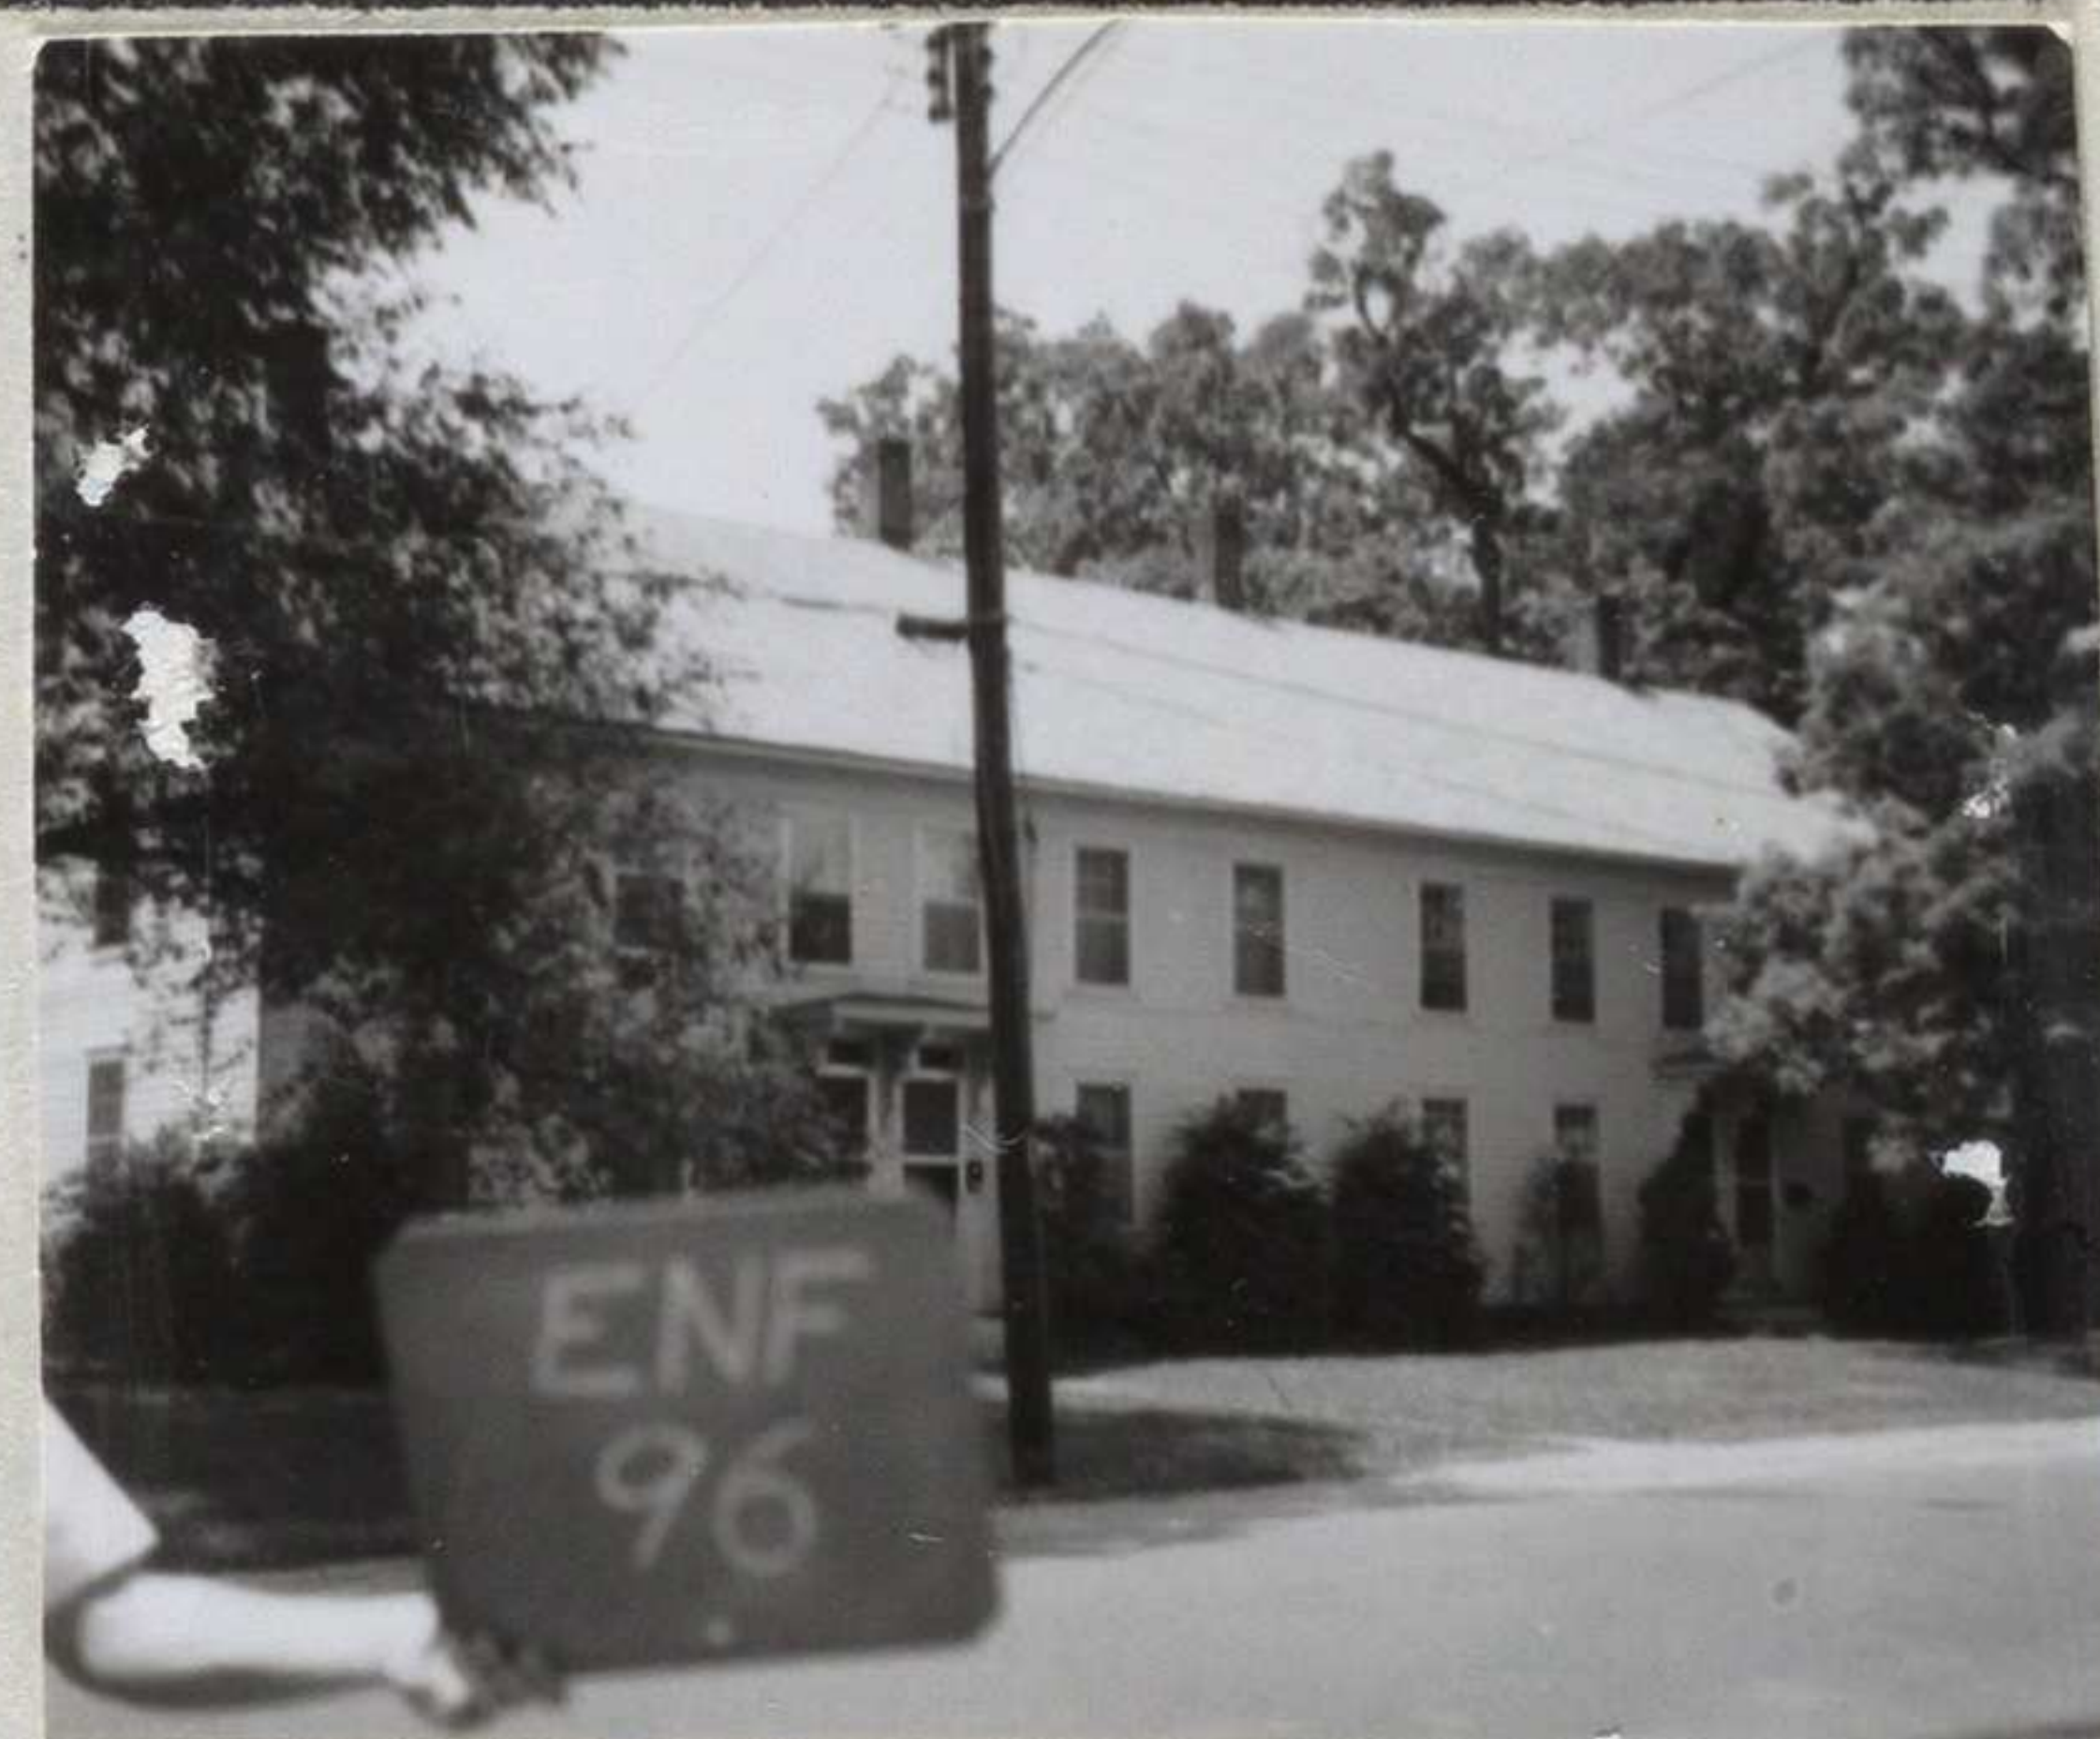
7. PHOTOGRAPH *Enf 96*

*This many family house has 12 bays built on
a ~~breaststone~~ brick foundation. The doorways with
their scrollwork canopies occupy bays 3, 4, 9 and 10 bays.
Each door has a two pane transom. Four chimneys
occur in elevation between bays 1+2, 5+6, 7+8 and
11 and 12.*

Endangered *No* Interior ? Exterior *good*

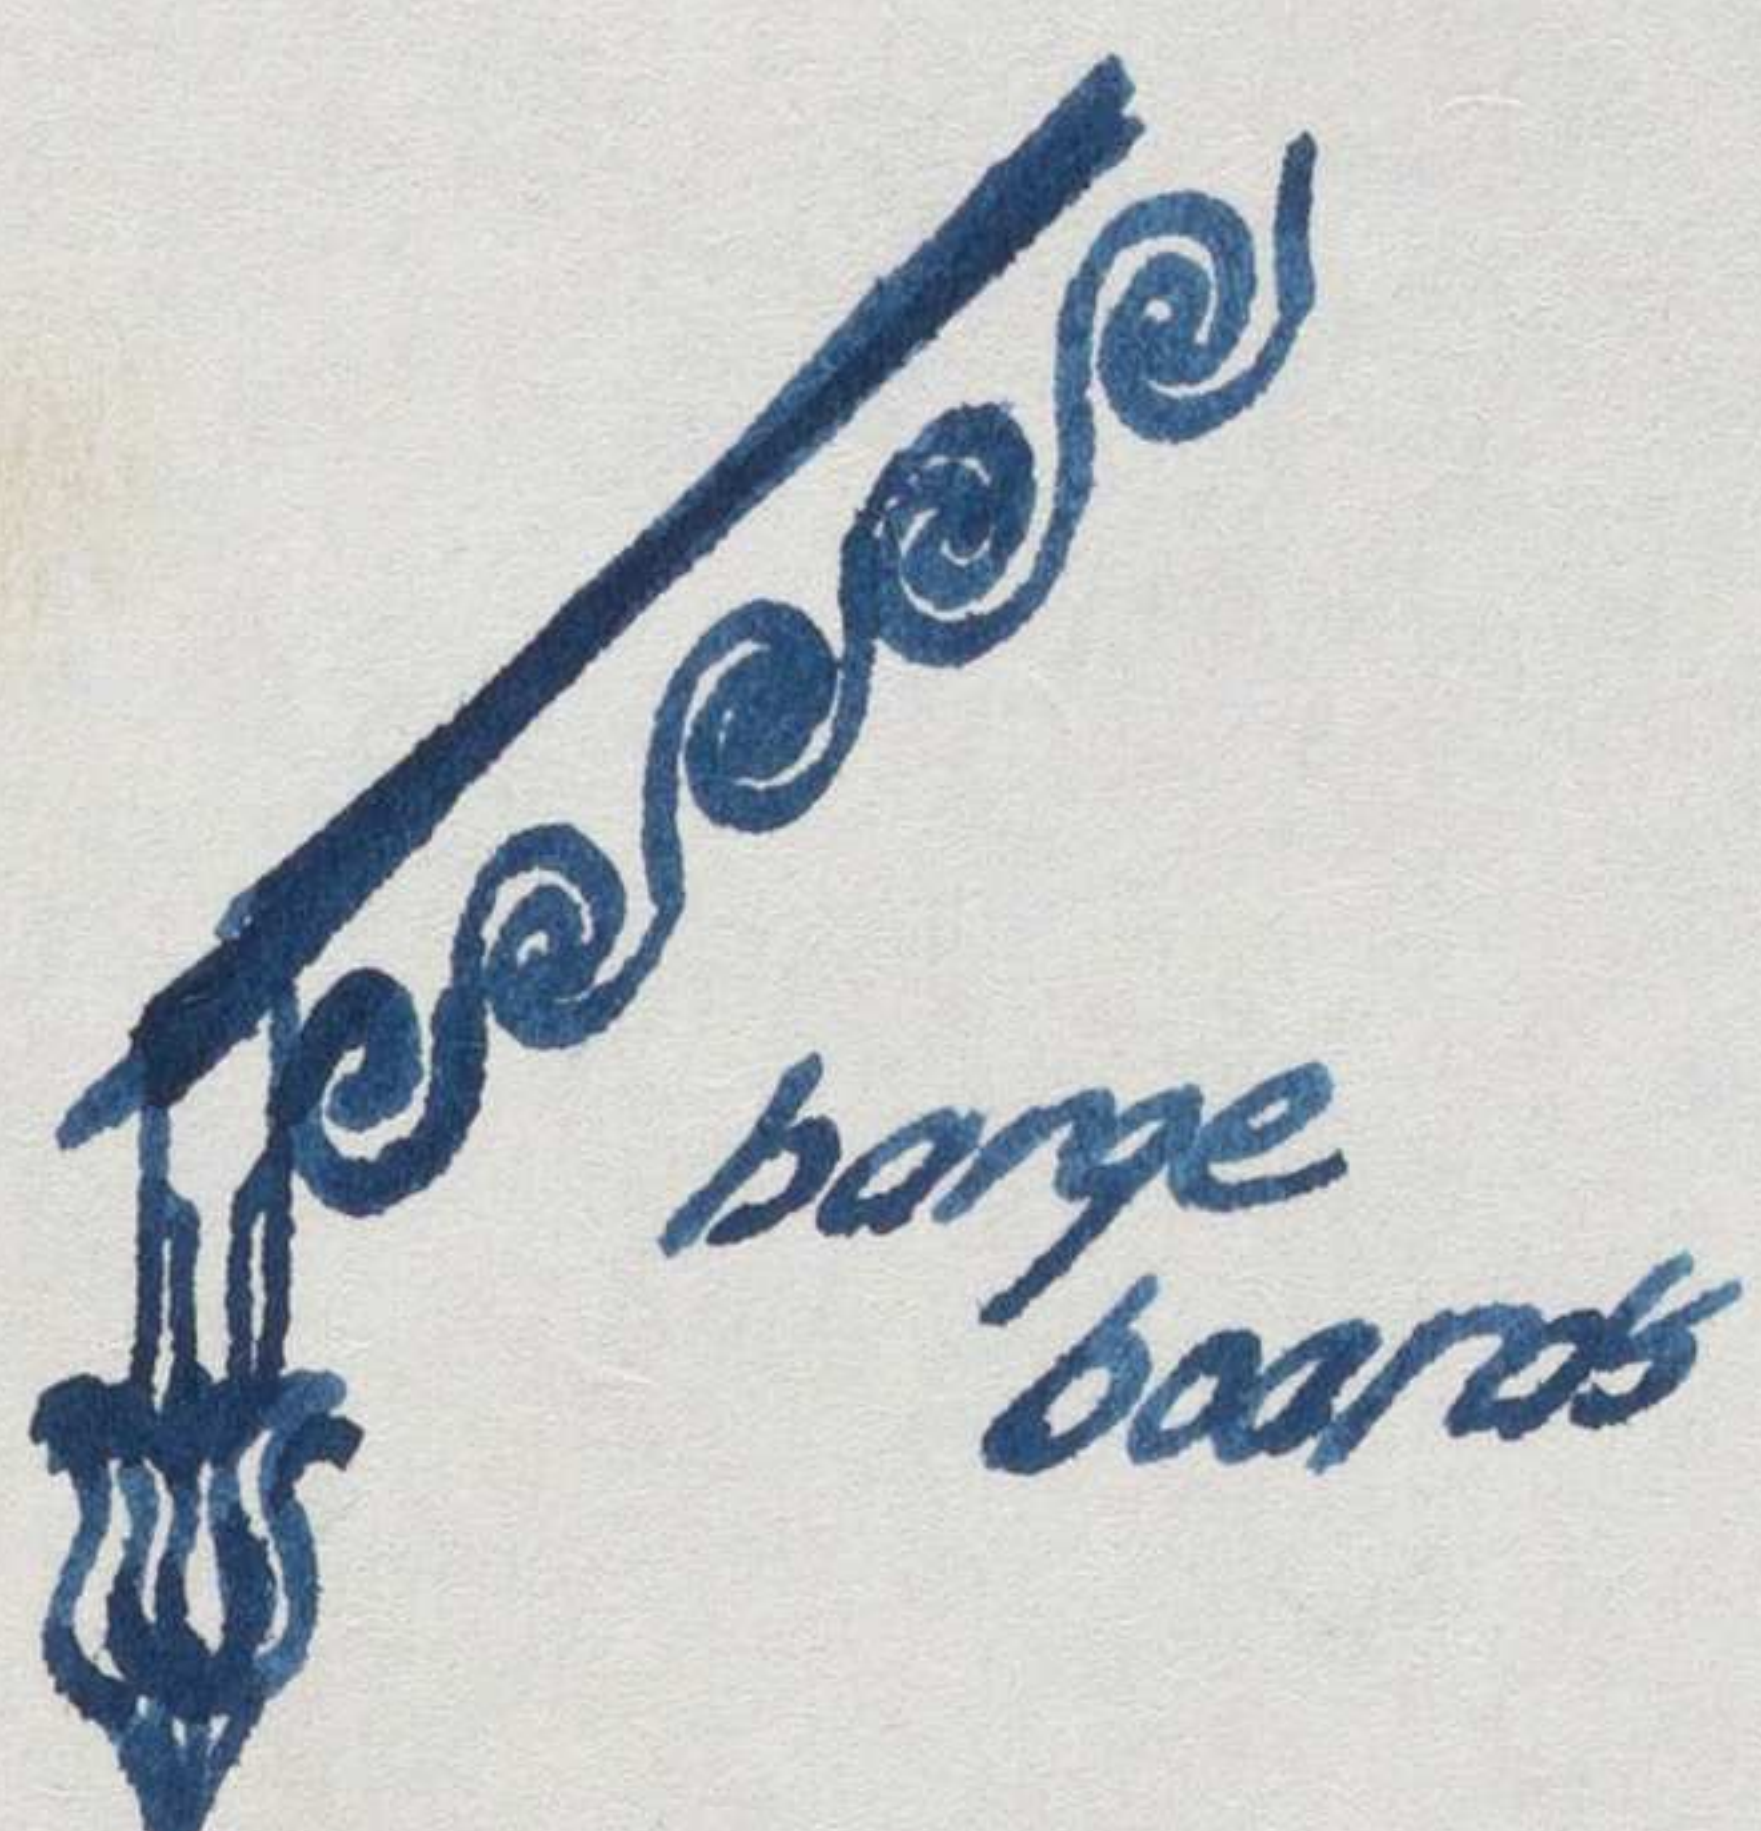
<p>barge boards</p></div> <div data-bbox="940 1456 1294 1654">

<p>1. STATE <u>CT</u> COUNTY <u>Hartford</u> TOWN <u>Enfield</u> VICINITY STREET NO. <u>South Maple Street</u> ORIGINAL OWNER <u>?</u> ORIGINAL USE <u>Residence</u> PRESENT OWNER <u>Henry</u> PRESENT USE <u>Residence</u> WALL CONSTRUCTION <u>clapboard</u> NO. OF STORIES <u>2</u></p>	<p>HISTORIC AMERICAN BUILDINGS SURVEY INVENTORY</p> <p>2. NAME</p> <p>DATE OR PERIOD <u>1840</u> STYLE <u>Carpenter Gothic</u> ARCHITECT BUILDER</p> <p>3. FOR LIBRARY OF CONGRESS USE</p>
<p>4. NOTABLE FEATURES, HISTORICAL SIGNIFICANCE AND DESCRIPTION</p> <p>OPEN TO PUBLIC <u>No</u></p> <p><i>This "T"-shaped house is built on a brick foundation, with only two days to the street. The roof angle is quite steep, the windows 6/6. The great feature of the house is the scrollwork on the barge boards and eaves.</i></p> <div data-bbox="342 1286 752 1710">

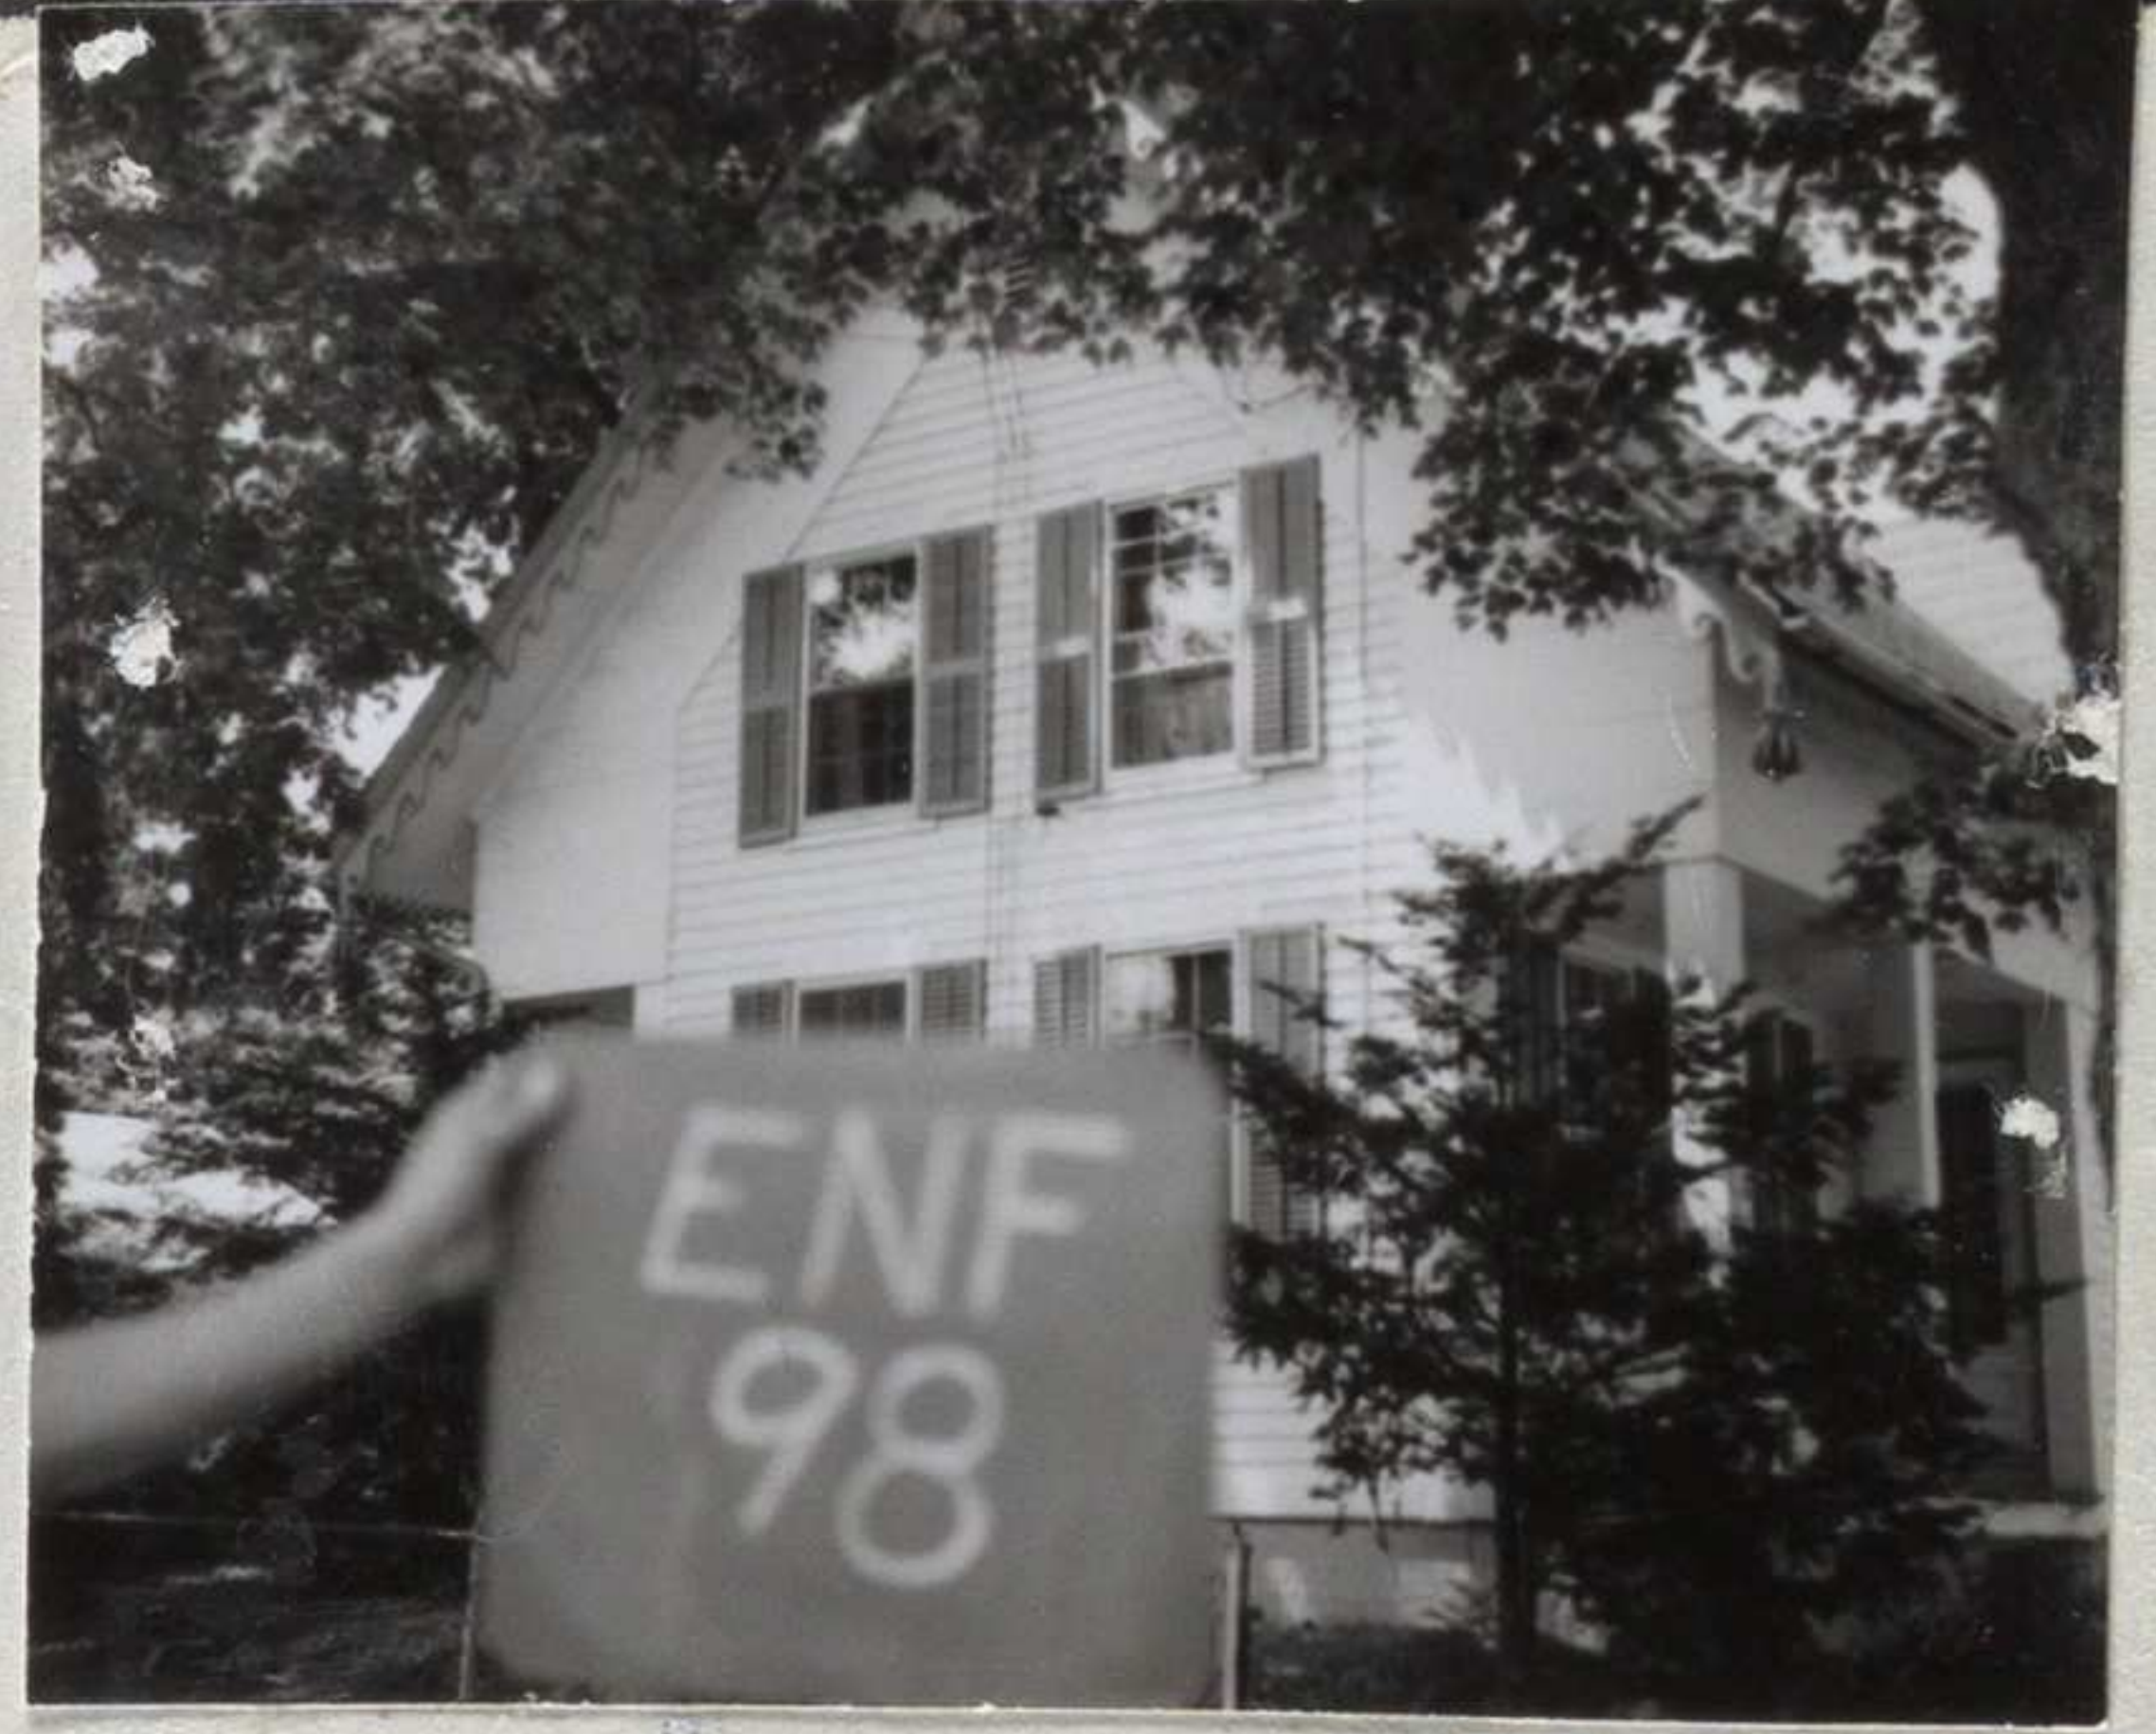
</div>	<p>7. PHOTOGRAPH <u>Enf 98</u></p> <div data-bbox="1493 1824 2023 2248">

<p>5. PHYSICAL CONDITION OF STRUCTURE</p> <p>Endangered <u>0</u> Interior <u>fair</u> Exterior <u>good</u></p> <div data-bbox="254 1852 1227 2290">

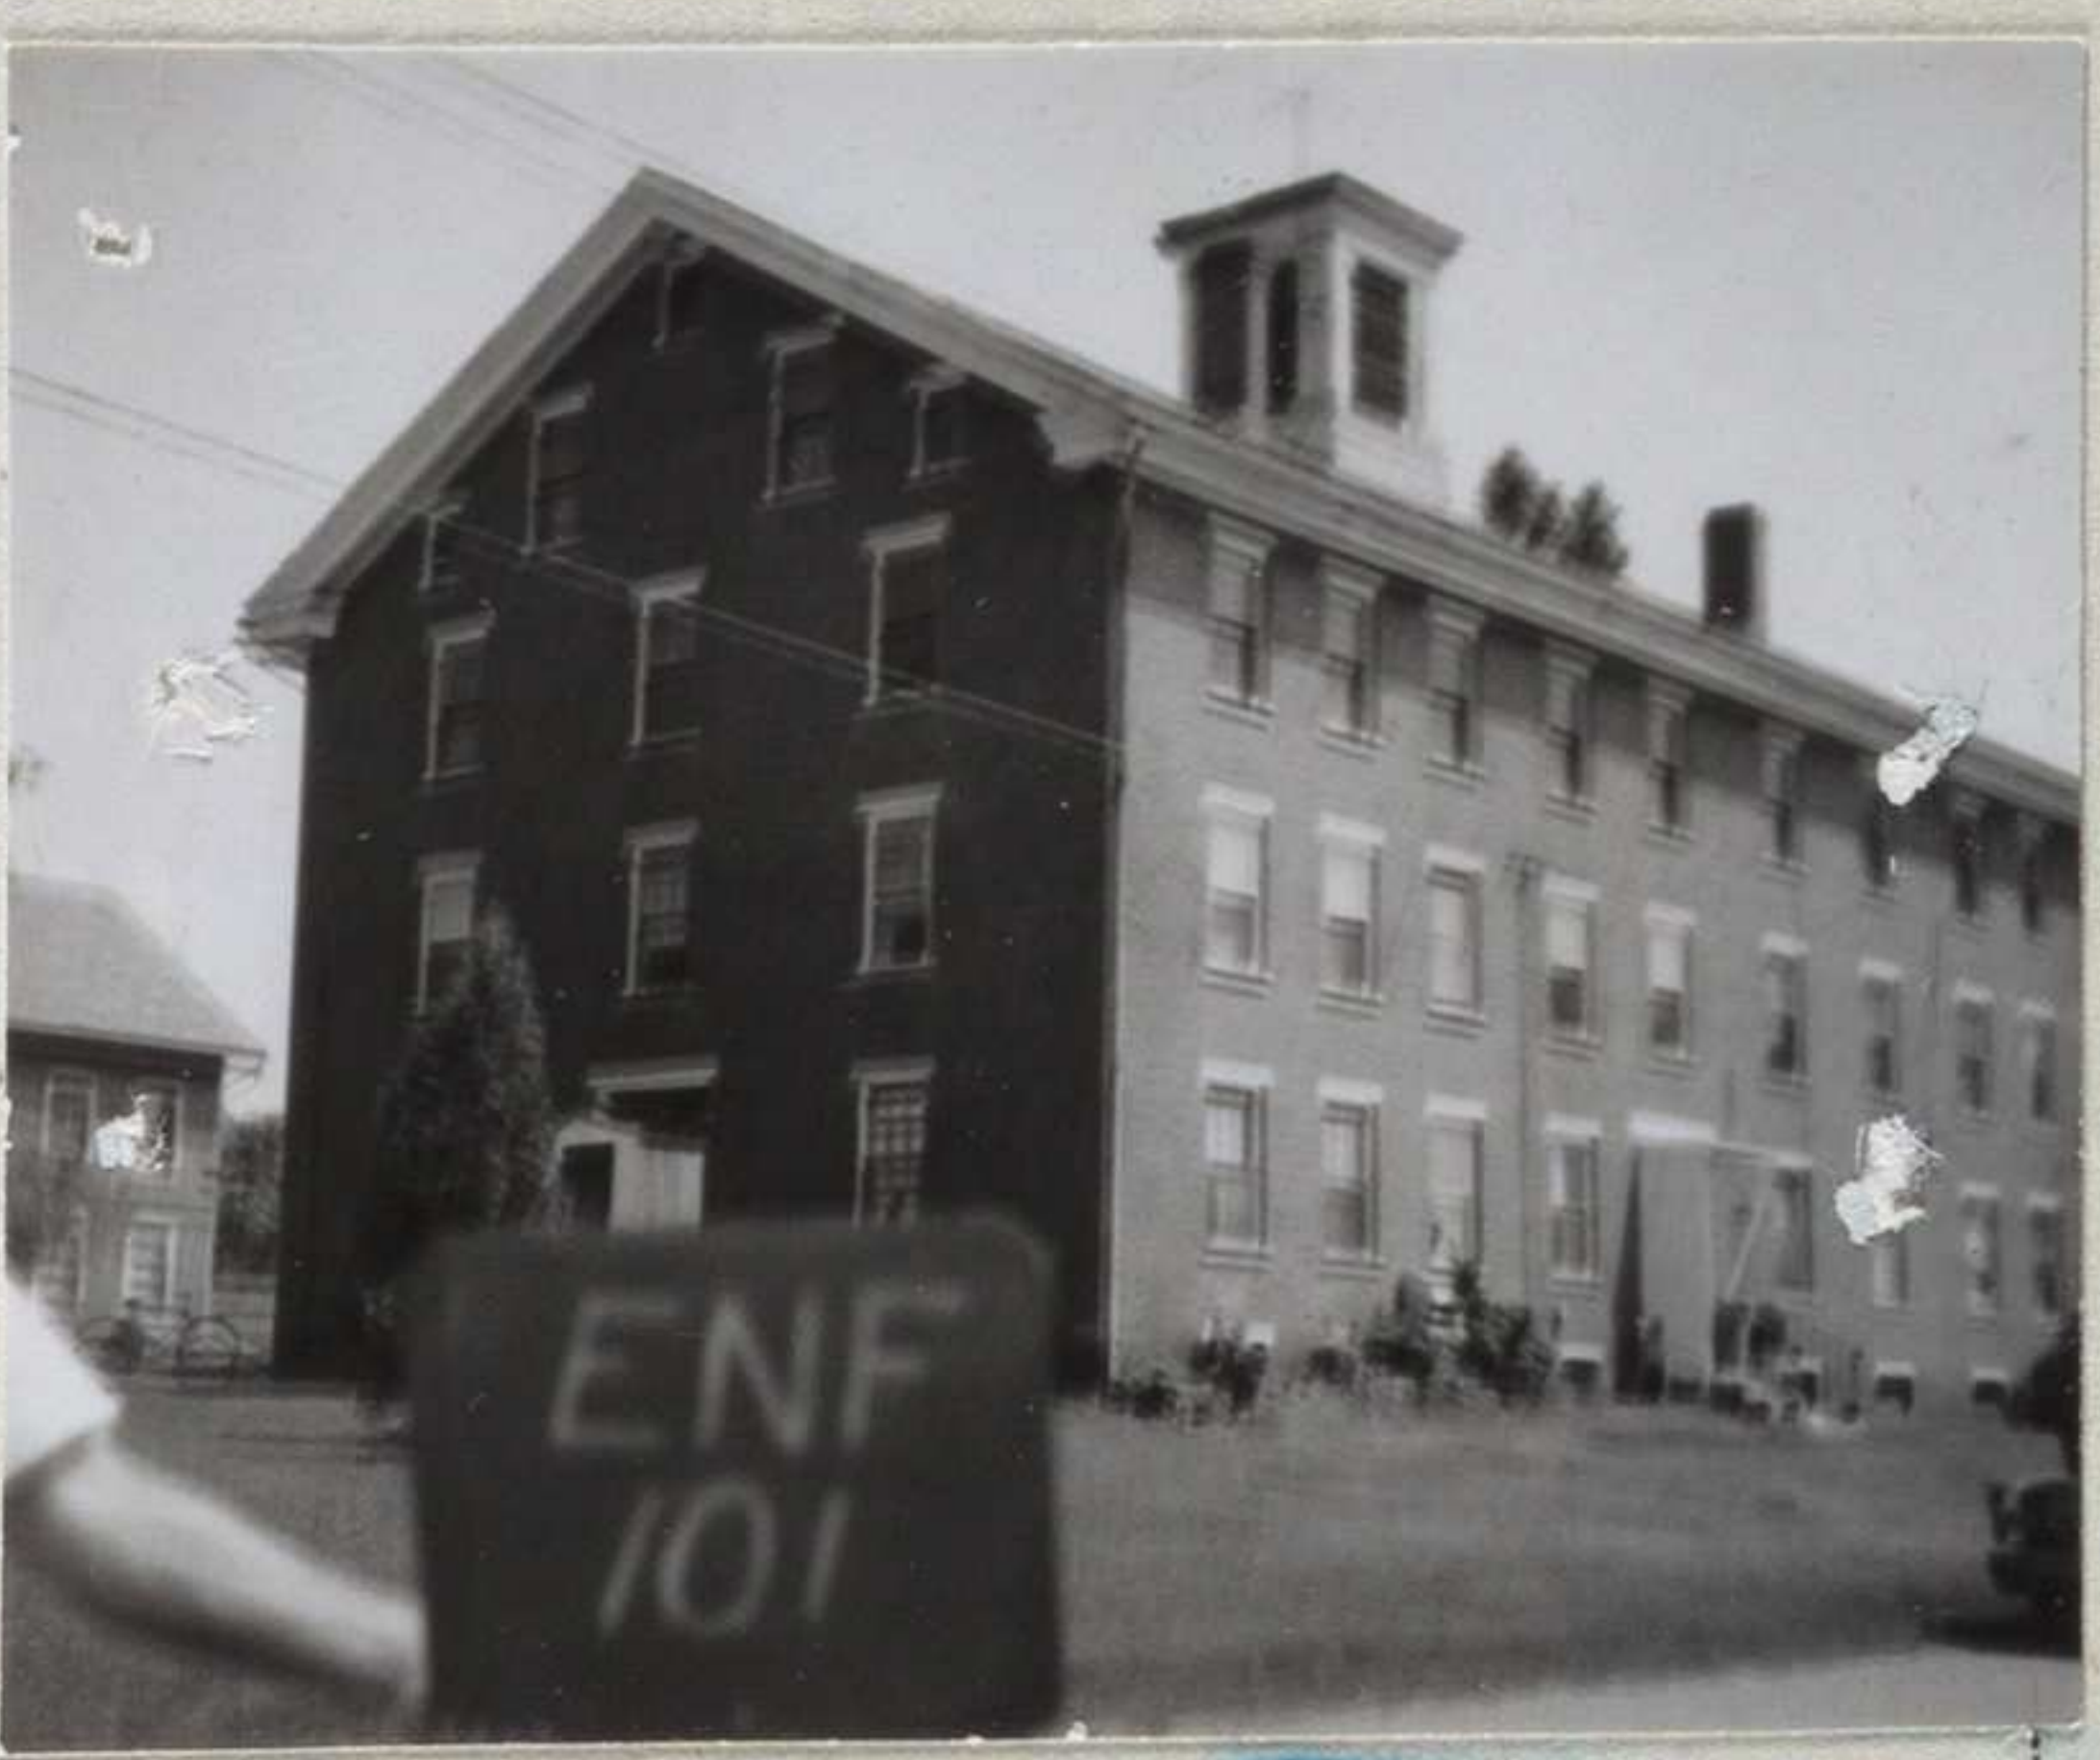
<p>7. PHOTOGRAPH <i>Enf 101</i></p>

<p>1. STATE <i>Ct</i> COUNTY <i>Hartford</i> TOWN <i>Enfield</i> VICINITY STREET NO. <i>Cybulski Road,</i></p> <p>ORIGINAL OWNER <i>Shakers</i> ORIGINAL USE <i>Multi-Residence</i> PRESENT OWNER <i>Cybulski</i> PRESENT USE <i>Multi Residence</i> WALL CONSTRUCTION <i>brick</i> NO.OF STORIES <i>3</i></p>		<p>HISTORIC AMERICAN BUILDINGS SURVEY INVENTORY</p> <p>2. NAME <i>Shaker House (South Family)</i> DATE OR PERIOD <i>1820-1830</i> STYLE <i>plain shaker.</i> ARCHITECT BUILDER <i>Shakers</i></p> <p>3. FOR LIBRARY OF CONGRESS USE</p>	
<p>4. NOTABLE FEATURES, HISTORICAL SIGNIFICANCE AND DESCRIPTION</p> <p>OPEN TO PUBLIC <i>No</i></p> <p><i>This building was the common shelter of most of the South family during Shaker ownership. Built on a brownstone foundation the house has 9 bays on its longer sides, 5 on the shorter ends. The central bay on all four sides holds a door with transom and lintel. The building is basically 3 stories high with 2 more formed under the gables. The windows are six/six with light stone lintels and sills. The medium pitched roof has a large square cupola at its center, and 4 chimneys at the center of the four quadrants formed by the cupola.</i></p>

<p>5. PHYSICAL CONDITION OF STRUCTURE</p> <p>Endangered <i>No</i> Interior <i>Poor</i> Exterior <i>good</i></p>
